Wood Destroying Insect Inspection Report

10-14-2011

**3647 Murfreesboro Pike
ANTIOCH, TN. 37013**

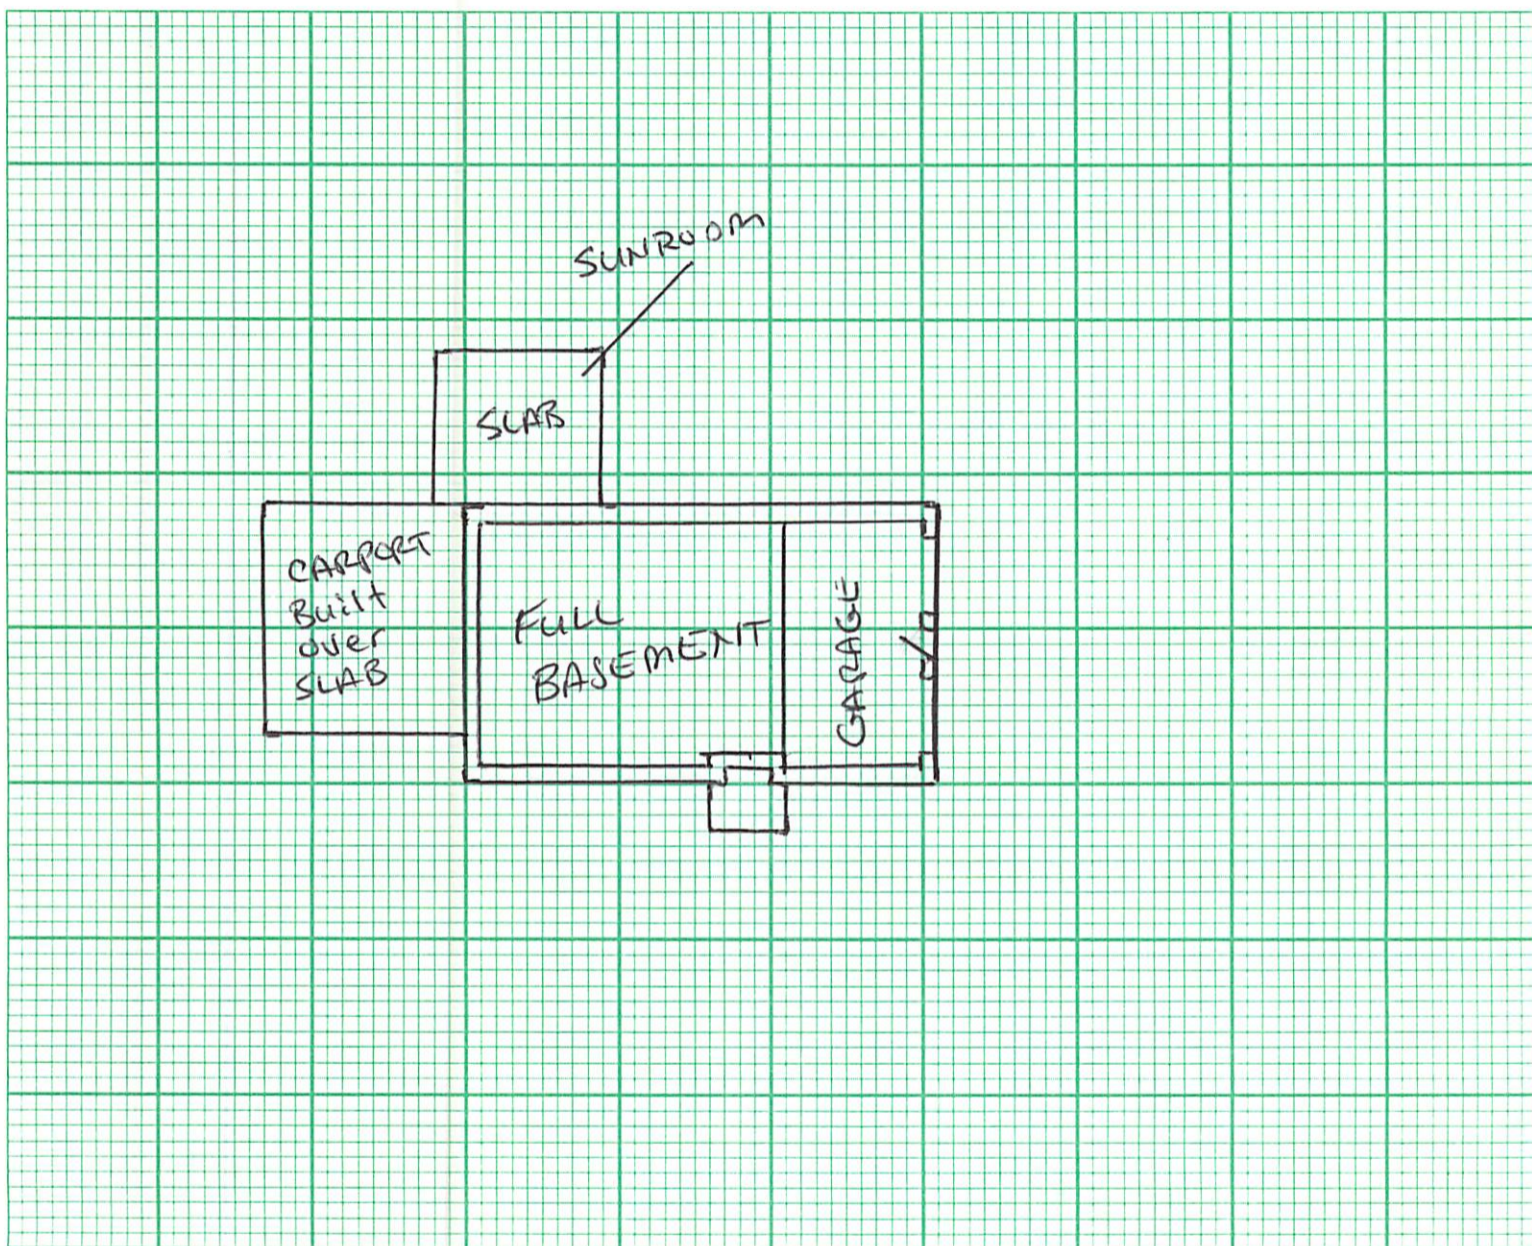
| <input checked="" type="checkbox"/> No evidence of termites found in structure | <input type="checkbox"/> Evidence of termite infestation in debris | | |
